Look out for Ice Ridges on the Lower Nose Fuselage

Ice ridges on the lower nose fuselage can cause Computed Airspeed (CAS) values delivered by the ADRs to be lower than the actual airspeed which may lead to unreliable airspeed events. This article describes the potential effect on the aircraft's systems from the takeoff phase and how to prevent such situation.

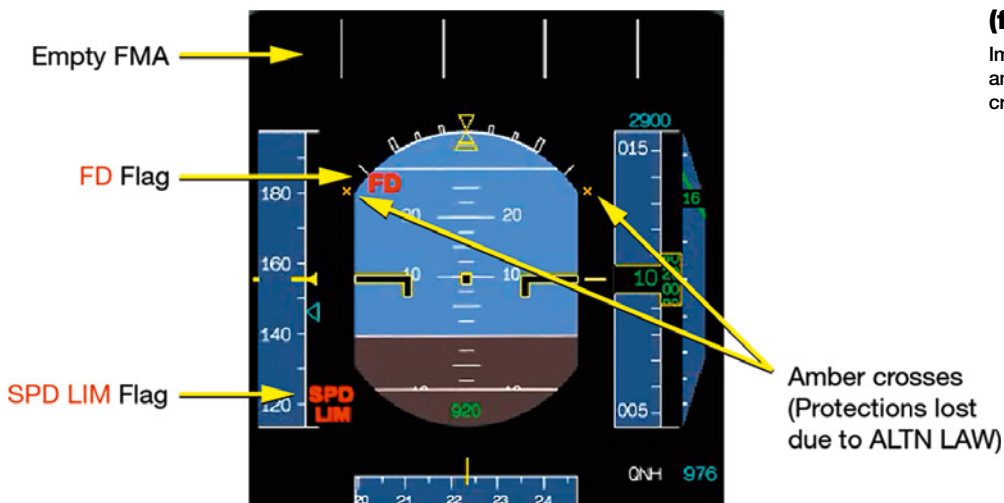
(fig.1)

With the ground servicing complete, the flight crew proceeded to takeoff. At lift-off, the flight controls law reverted to alternate law and the **AUTO FLT A/THR OFF** ECAM caution triggered. 12 seconds later, the Flight Directors (FD), Characteristic Speeds, TLU function and Autopilot availability were also lost. The **FD** and **SPD LIM** red flags were displayed on both PFD **(fig.1)** and at the end of the ECAM take-off inhibition phase, when the aircraft reached 1500ft, three ECAM alerts were displayed:

- **NAV ADR DISAGREE**
- **F/CTL ALTN LAW**
- **AUTO FLT RUD TRV LIM SYS**

Impact on the PFD indications: **SPD LIM** and **FD** red flags, empty FMA and amber crosses of the alternate law

The flight crew identified an airspeed discrepancy issue and then compared PFD1, PFD2 and the standby speed indications with the ground speed on the navigation display. They proceeded to switch off ADR 1+3 and performed an in-flight turn-back with the ADR2 ON.

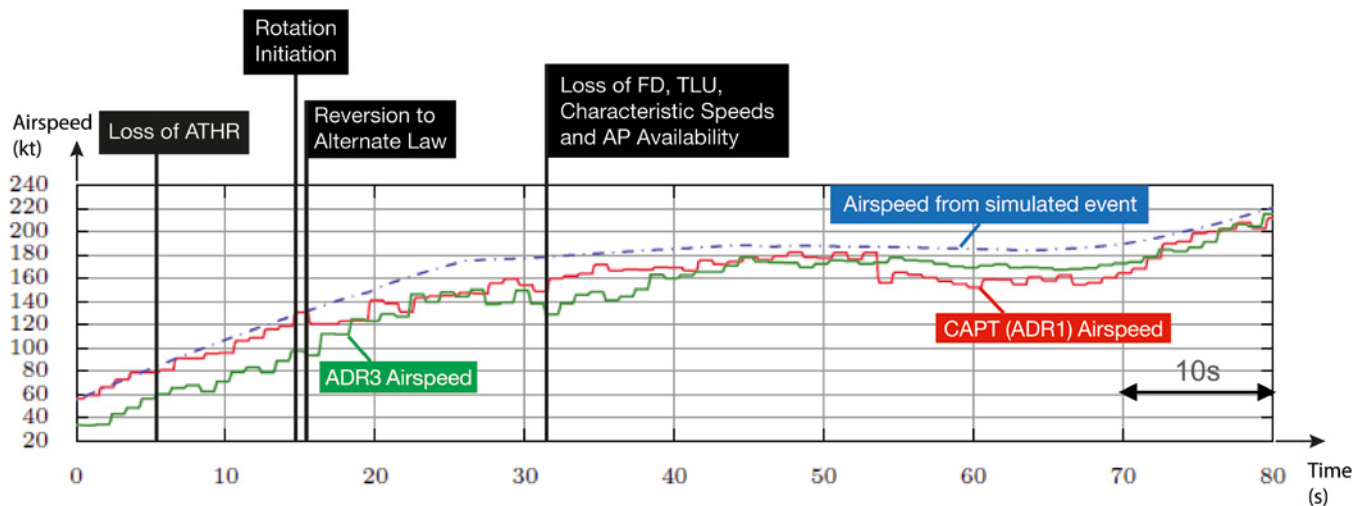
(fig.2)

The resulting Computed Airspeed (CAS) from the simulation, representative of the actual airspeed is shown in blue on the graph **(fig.2)**. This was compared to the recorded CAPT CAS (from ADR1) shown in red and ADR3 CAS, which is shown in green on the graph **(fig.2)**.

From the beginning of the take-off roll, ADR3 airspeed is perpetually underestimated up to 40kts and ADR1 airspeed is underestimated from take-off roll up to 10kts and from rotation up to 35kts.

Comparison between recorded ADR1 & ADR3 airspeeds and the simulated airspeed

The investigation concluded that the root cause of such speed discrepancies was the build-up of ice ridges on the lower nose fuselage in front of the Pitot probes and lower nose fuselage not de-iced before departure. This creates airflow perturbations and causes airspeed computed value to be lower than the actual airspeed.

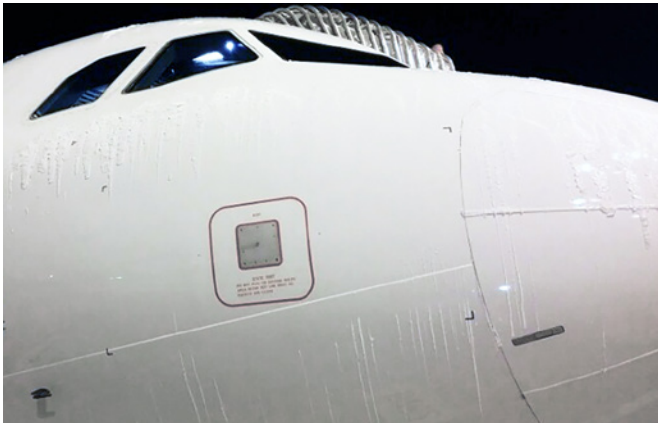
The main cause of ice ridges over the lower nose fuselage of the aircraft is ice accretion during a long stay on ground in cold conditions **(fig.3)**. A review of in-service events from the last 6 years shows that a large majority of ice ridges related events occurred during the first flight of the day.

(fig.3)
Example of thin ice ridges forward of the pitot probes of an A320 family aircraft

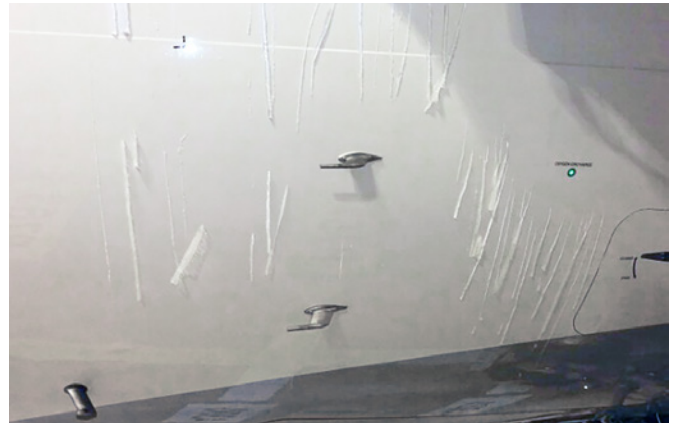
Reported events also show that ice ridges may be dislodged during the flight or may remain attached to the lower nose fuselage for the entire flight **(fig.4)**.

(fig.4)
Example of ice ridges that remain on the lower fuselage even after completing a flight.

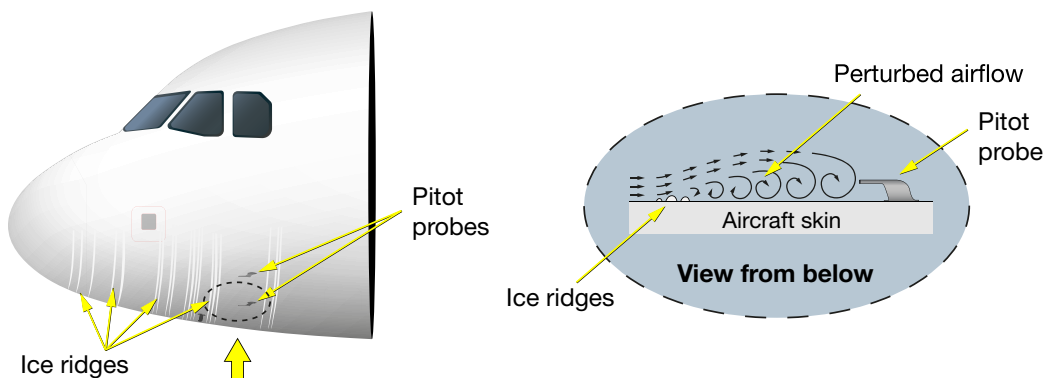
The presence of ice ridges located forward of the Pitot probes on the lower nose fuselage creates airflow perturbations **(fig.5)** and may lead to airspeed data from the ADR of the impacted probe(s) to be lower than the actual airspeed.

The effect of ice ridges on the measured airspeed value will depend on the location, shape and number of ice ridges present. A large ice ridge but also successive thin ice ridges can significantly impact the airspeed measurement.

(fig.5)
Effects of the ice ridges on the airflow forward of the Pitot probes
